Innovative concepts and technologies in the restoration of St Martin church at Meise (B)

Dionys Van Gemert, Triconsult nv, Lummen, en KU Leuven
Gert Heirman, Triconsult nv, Lummen, en UAntwerpen
Dirk Geeroms , Architect, Gent

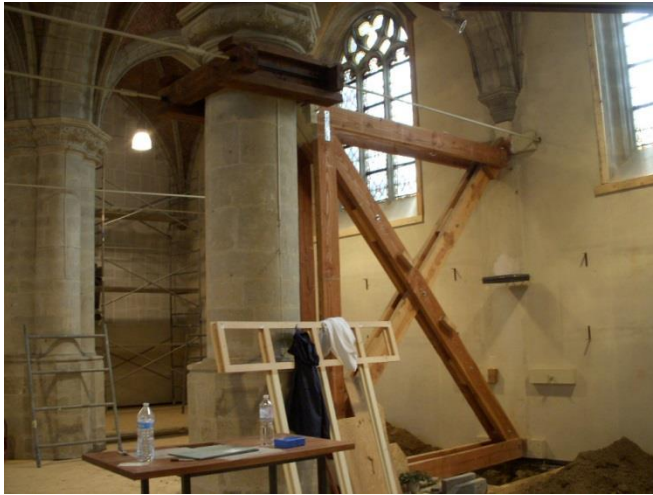
The tension rods are connected to the exterior stabilizing frames, Fig. 4. The bottom layer of anchors at the level of the column heads is shown Fig. 5. The free standing columns are enclosed by means of two tension rods. These two rods are fixed to a wooden collar at the column head, ensuring that the same anchors can also be used to balance the horizontal forces coming from the vaults. At the level of the free standing columns a timber Andreas cross is placed in the side-aisles to block the north-south movement of walls and columns. The collar and the Andreas cross constructions are shown in Fig. 12.

Fig. 12 Collar and Andreas cross in side-aisle

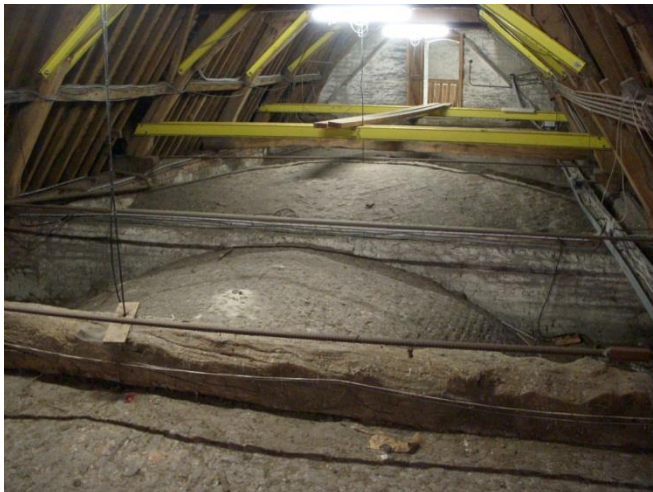
The anchors above the vaults are shown in Fig. 13. The yellow steel beams replace the deteriorated timber ties of the roof trusses.

Fig. 13 Anchors above nave vaults

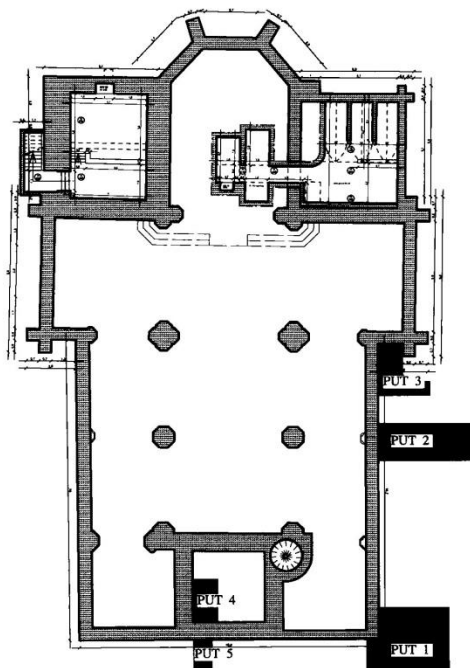
Three investigation pits were dug near the foundation of the south façade, and two pits next to the tower. The location of the five pits is shown in Fig. 16. The investigations were carried out in July 2011.

Fig. 16 Location of 5 investigation pits

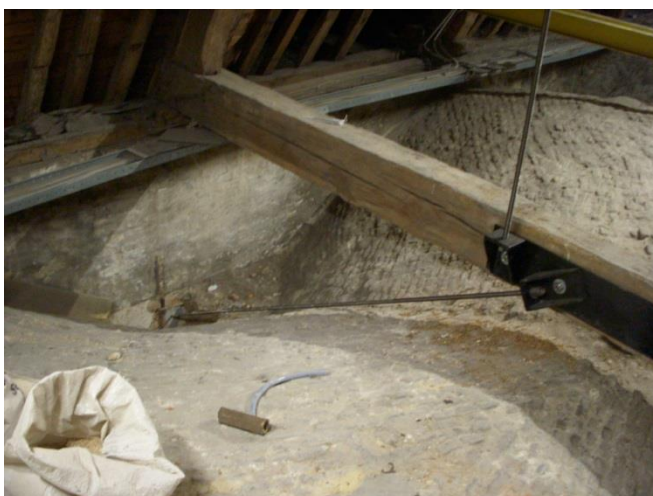
The forces from the vaults above the side aisles are taken up by the new buttress and by the nave wall, where the tensile rod type A (Fig. 22) locks the buttress and the nave wall. The forces from the nave vaults are taken up by the inclined rods type B, connected to the main beam of the roof truss. The vertical component of the force in the tensile rod is compensated by the weight of the wall part above the crossing between anchors A and B. To avoid deflection of the main beam, it is hung up with two vertical tensile rods type C to the triangular structure of the roof truss. Fig. 22 also shows schematically the connection of the tensile rods type A in the top of the buttress. Figures 27 to 29 show the practical execution of this innovative tensile anchor system.

Fig. 27 Inclined anchor type B

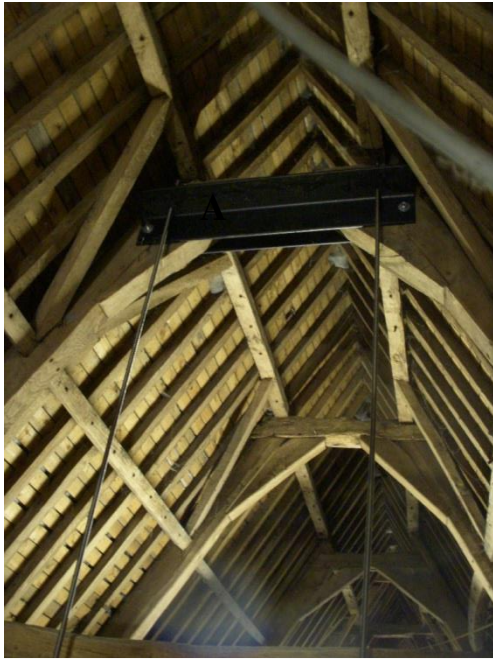
Fig. 28 Suspension of main beam with anchors type C

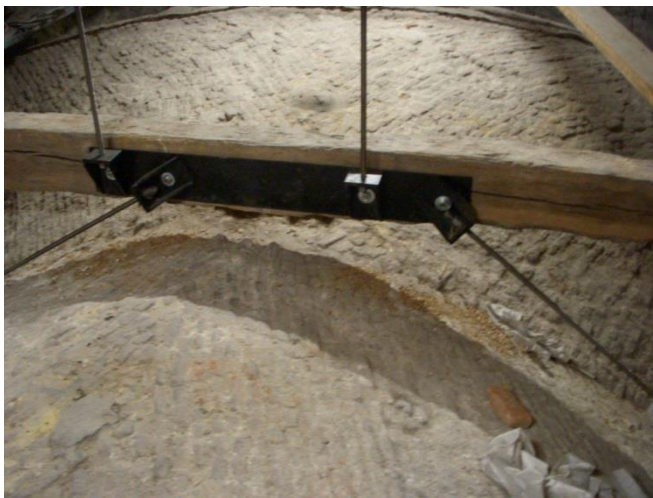
Fig. 29 Connection of anchors type B with main timber beam of roof truss

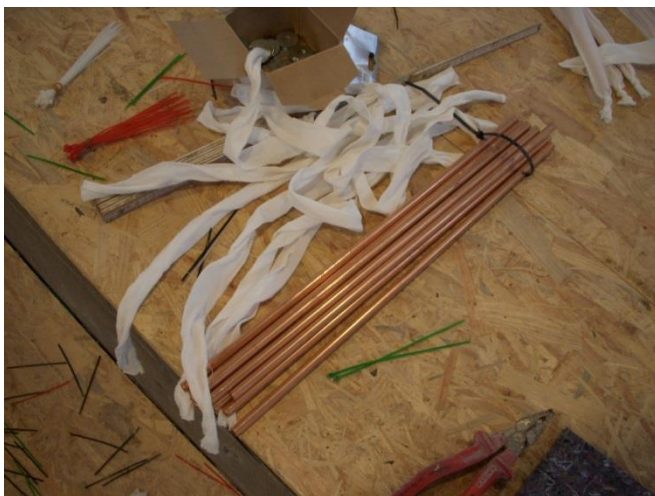
The brickwork of the vault in the bulged zones is heavily cracked and very soft. Combined with the loose backfill at the vault tips, this creates a dangerous and unstable situation, ultimately leading to brick fall. For that reason the bulges are consolidated with sock anchors, provided with a wider pinion at the vault inside to support the masonry. Sock anchors have a diameter of 10 to 12 mm, with at the center a reinforcing element with diameter 6 to 8 mm. Sock anchors can be placed in a borehole of 12 to 14 mm. Pinion and sock anchor are glued in the borehole with a mineral grout. The borehole at the inside of the vault is widened to allow a hidden placement of anchor and pinion.

Fig. 32 Sock anchors: copper injection and reinforcing tube

In this case copper tubes have been used as reinforcing element, Fig. 32 and 33. The tube is put in a textile sock. The tube is used to inject the mineral grout in the sock. The sock is pressed against the borehole wall by the injected grout. The small amount of grout that penetrates through the sock assures the bond of the anchor in the borehole.

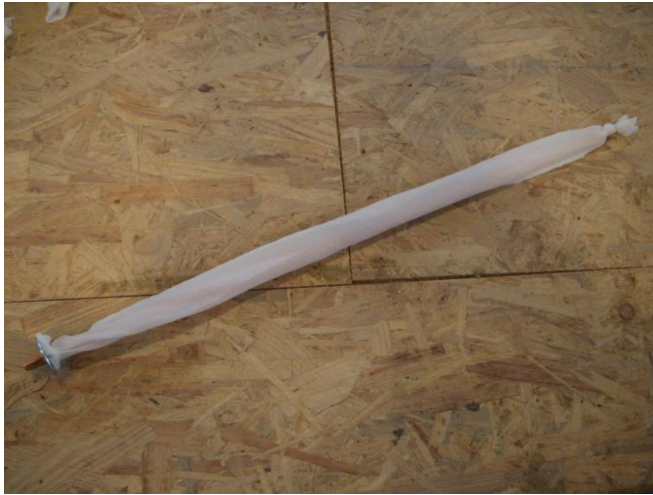
Fig. 33 Completed sock anchor, with pinion at the left end

Five suspicious vault zones have been consolidated and strengthened with this type of sock anchors.

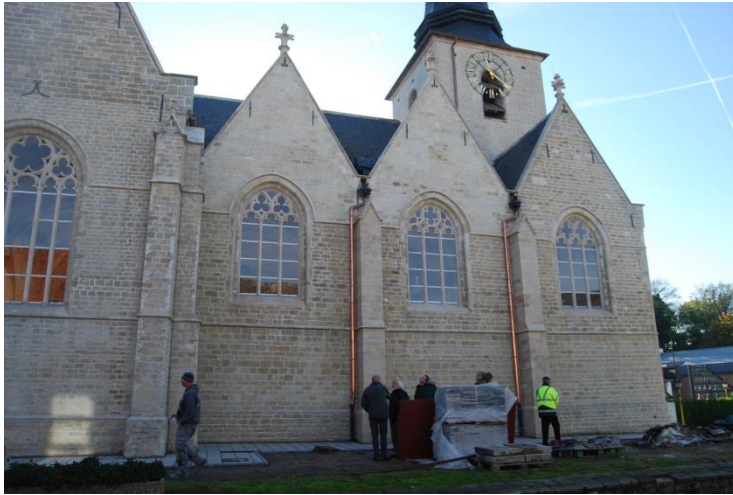
Because of this strong degradation it was decided to demount the three northern wimpergs piece by piece and stone by stone, and to replace them in the same configuration. Heavily degraded blocks were recut when possible. Missing blocks were replaced by new stones of Massangis roche jaune. The replaced parament is anchored in the backing masonry by means of grouted anchors. For each row of parament stones, anchors are grouted with ternary grout in the masonry behind, and the vertical joint was first filled with mortar as good as possible. After that the vertical joint was further filled with ternary grout to obtain a complete filling of all voids between mortar and masonry, as well as to obtain a partial consolidation of the backing masonry. This procedure is repeated at each row of replaced parament stones. The consistency of the grout allows its use for about two hours. Therefore, grouting did not hinder at all the block laying activity. The execution is shown in Figures 39 and 40.

Fig. 40 Renewed wimpergs at north side (Photograph D. Snauwaert)

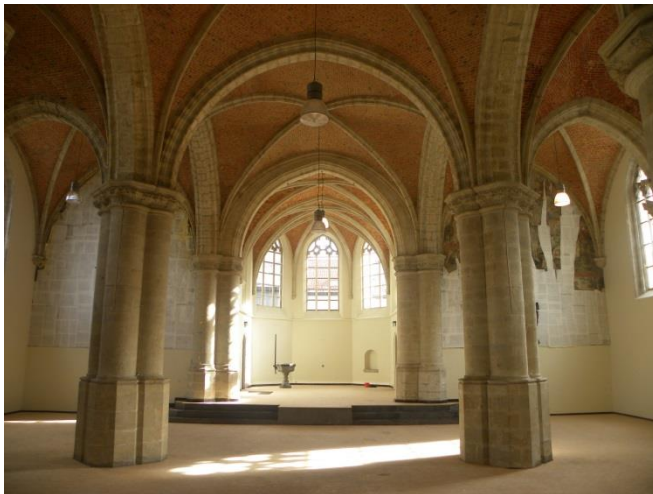
The integrated approach of the restoration of St Martin church at Meise resulted in an open and attractive building for the community, without disturbing tensile anchors or supporting frames in the interior, Fig. 41.

Fig. 41 Interior of St Martin church after restoration
